# Foundation Investigation at Hickory Log Creek Dam, Canton, Georgia

Hickory Log Creek Dam is a proposed 55 meter high roller compacted concrete dam located on a tributary of the Etowah River near Canton, Georgia. The site characterization involved several approaches that facilitated the rapid foundation investigation schedule. These included identification of critical data needs, design of the program to collect these data, and selection of preferred data acquisition and evaluation. The foundation area of the dam is composed of fresh relatively unfractured mica schist in the stream valley and a mantle of residual soil and partially weathered rock on the abutment hillslopes.

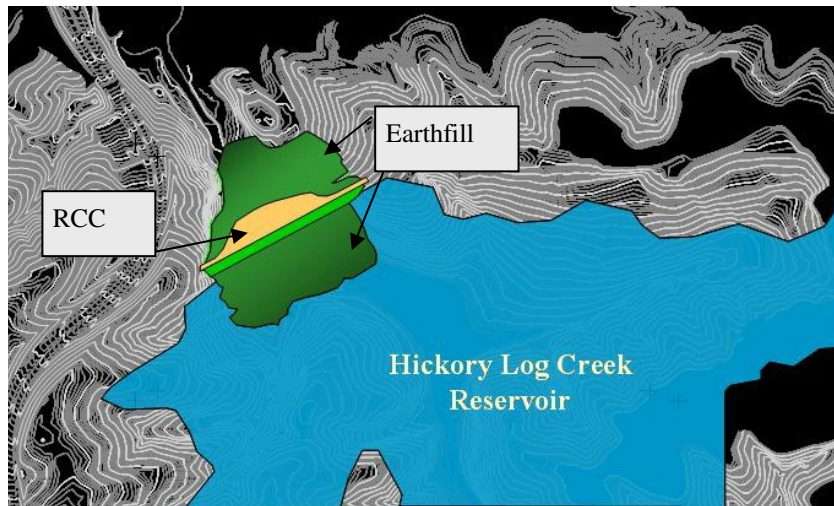
**Figure 2.** Earthfill versus RCC Dam Footprints

Our approach to planning the field investigation began with conceptualizing the potential final design products. Because the data was being used to select a type of dam from a number of potential alternatives, the data that might be needed for the final design varied. The footprint of the two primary alternatives, earthfill dam and roller compacted concrete (RCC) dam, are shown on Figure 2. The data needs for each dam alternative were developed by considering the data input parameters required for the types of analyses required for design and summarized on a project data flow chart.

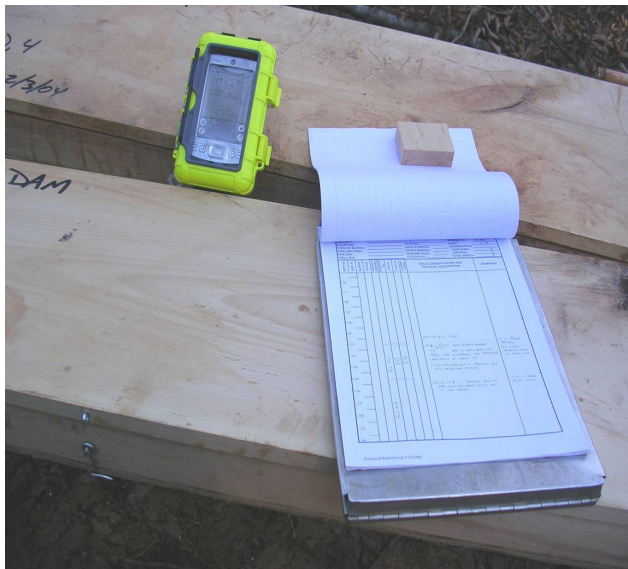
Figure 3. Digital and Paper Logging

One of the primary products of foundation investigations are the boring logs. The logs provide the fundamental data report on which much of the design is based. Of critical importance on a fast-track project with multiple drill rigs is consistency and speed of product delivery. On the Hickory Log project we had five geologists and engineers logging soil and rock, each with different levels of experience and training. Schnabel has specific methodologies for soil and rock description, but typically hand-written logs from different personnel can vary substantially in details thus requiring review, editing, and associated delays. For this project we utilized handheld personal digital assistants (PDAs) housed in weatherproof cases (Figure 3) with the program PLog. The program presents the user with a series of input screens for entry of related field data (Figure 4). The data is typically selected from a “pick list” of terms. These terms are pre-loaded on each PDA and can be customized for a specific project or utilize the organization’s standard description terminology.

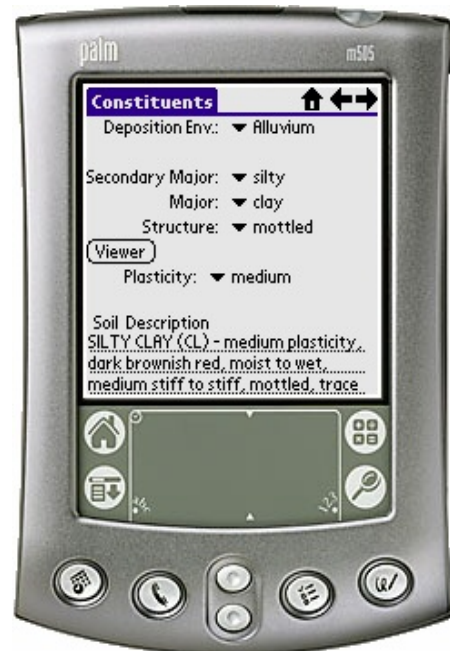
Figure 4. Example PLog Input

At the end of each field day the PDAs were synchronized on a laptop computer, imported into gINT, and printed. This draft log was then checked by the field personnel within 24 hours while the information was still fresh in their minds. Final logs could easily be generated within hours of the completion of a boring and typically only required minor editing. Geologic profiles and cross sections could also be plotted directly from this data using gINT.

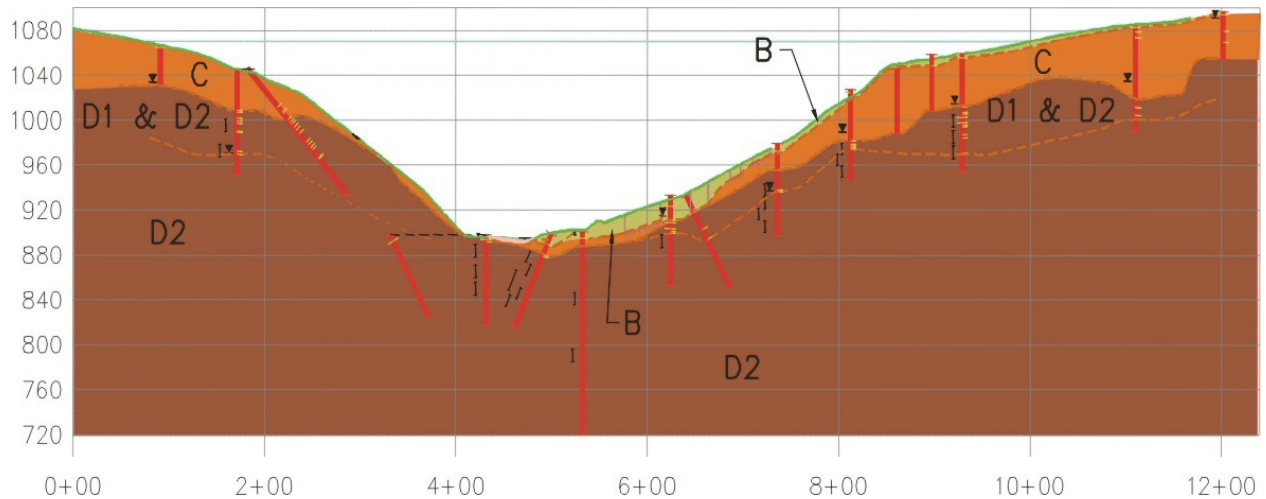
The geologic profile along the baseline shows a gradually thickening zone of Stratum B1 and B2 (residual soil) and Stratum C (Partially Weathered Rock) on the right side of the stream. Stratum B1 and B2 are present from near the stream bank and thicken to about 5 ft thick at the base of the slope, then to 58 ft near the top of the steep portion of hillslope, and then 70 ft thick. On the left side of the stream the Stratum B1/B2 and C zone is intermittent, with areas of rock outcrop (Stratum D1) exposed on this hillslope. Stratum D1 material is very thin or not present beneath the stream valley, and thickens up each side of the valley to about 40 ft thick at the top of the right and left abutment slopes.

**Figure 5.** Geologic Profile Along Dam Centerline (looking downstream)

A series of geologic profiles and cross sections were developed based on the borings drilled during the field exploration program. A profile along the dam centerline shows the interpretation of the subsurface information for the proposed dam (Figure 5).
